Manhole Inspection Summary

Manhole # S29CC2019MH

Location Address: **5511 CHARLES ST**

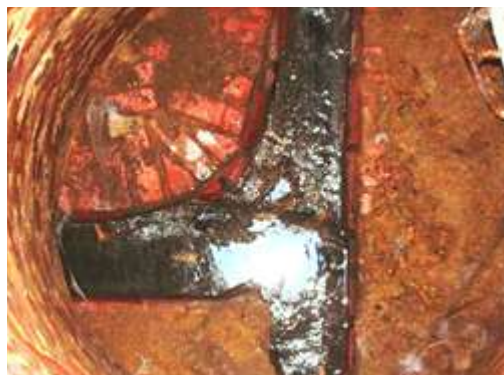
Top View

Corroded steps. Evidence of surcharge - Bench Channel debris.

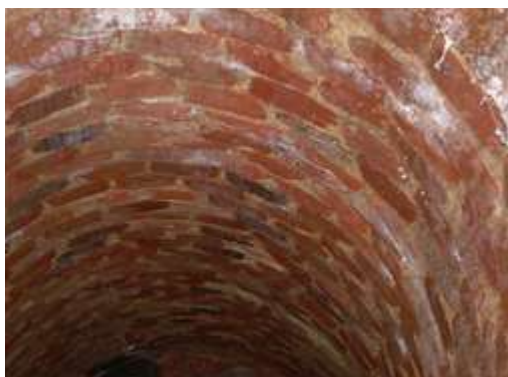
Defect

Adjustment and Barrel infiltration - other side.

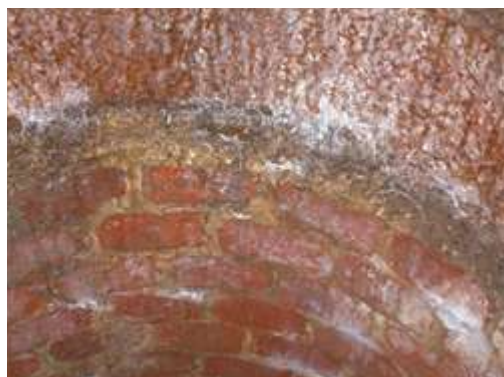
Defect

Adjustment infiltration.

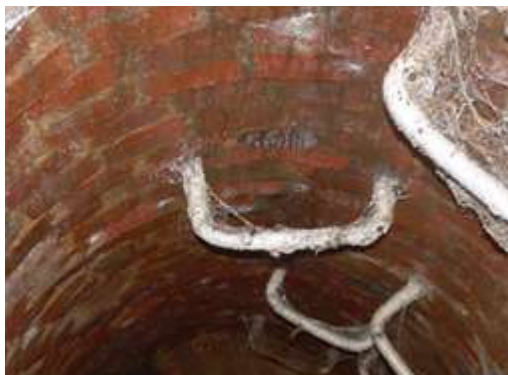
Defect

Adjustment and Barrel infiltration.

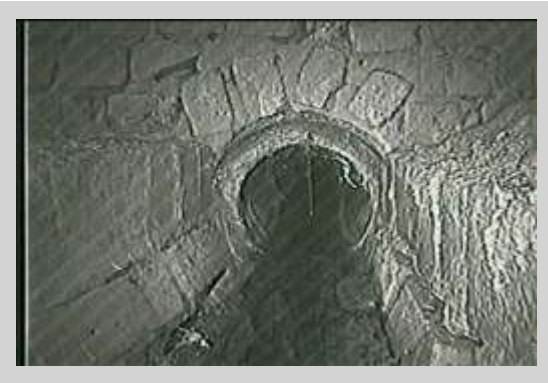
8 in. Circular Gravity Sewer Pipe Out @ 12 O'Clock

Channel deterioration.

Infiltration: **Evidence** Pipe Seal Cond: **Unknown**

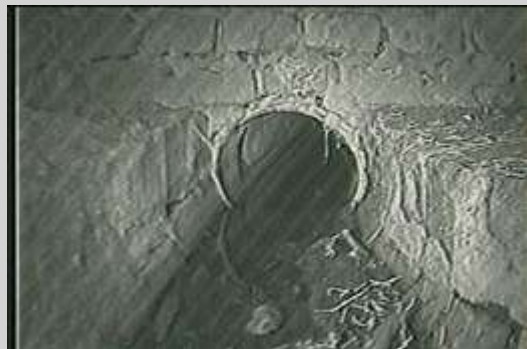
Pipe In @ 9 O'Clock

Channel deterioration.

Pipe Seal Cond: **Roots**
